Thermographic Survey

Sempatap Insulation
On 8
Domestic Properties

Wolverhampton City
Council

Thermographic Survey Report

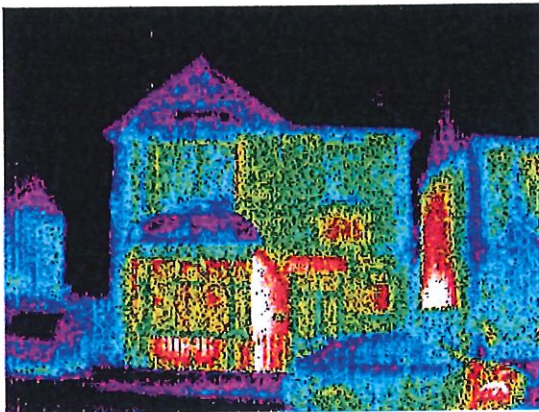
Before thermal

Thermographic analysis of the before shot, showed inconsistent temperatures in red and yellow colours. A large hot spot can be seen to the right of the bay window suggesting poor detailing at the junction; however, wind sheltering may also contribute. Increased temperatures are also seen below the upper right hand window indicative of missing/ damaged insulation; however the size and shape of the anomaly suggests that it is due to an internal heat source. Analysis after insulation reveals consistent temperatures across the entire elevation which indicates a well insulated property in good condition.

- Sempatap Insulation

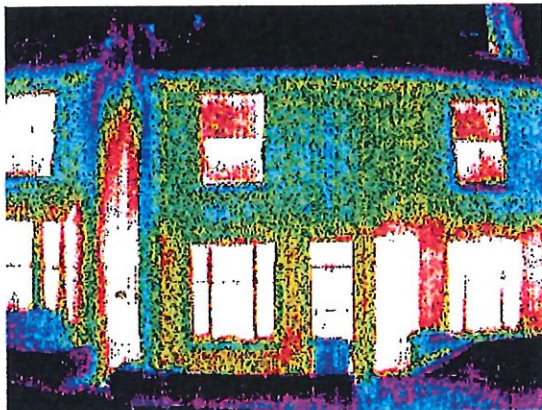
Before thermal

In the before image, inconsistent temperatures can be seen in red and yellow colours indicating heat loss due to poor detailing or missing/ damaged insulation. Warmer temperatures are seen on the bottom level of this property suggesting heating is on compared to the above level; however it could simply be there is no insulation at all. Analysis of the property after insulation reveals significantly reduced heat loss across the elevation suggesting a much more energy efficient property.

- Sempatap Insulation

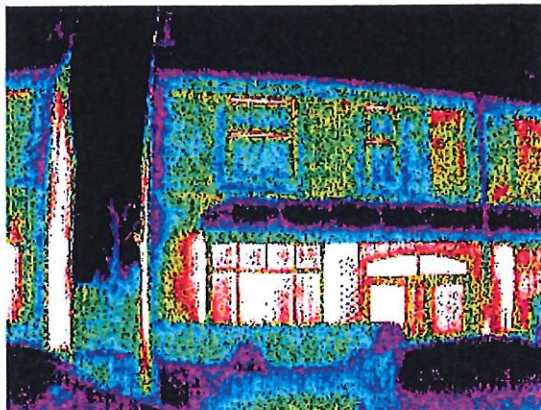
Before thermal

Thermographic analysis of the above thermal image taken before the building renovations reveals increased temperatures to the left of the bottom window indicative of missing/damaged insulation and/or poor detailing. Analysis after remedial measures were taken reveals slightly more consistent temperatures across the property; however, increased temperatures indicative of heat loss can still be seen around lower windows. Although this is minor we advise that it is investigated further.

- Sempatap Insulation

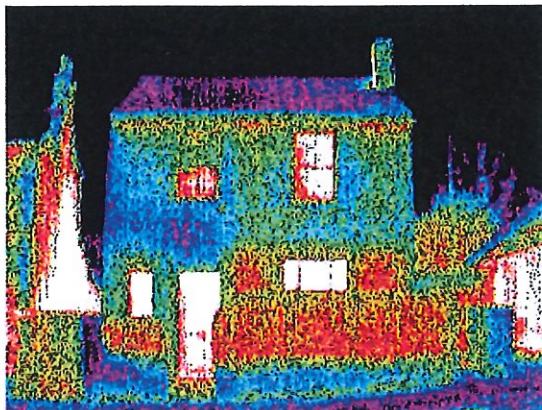
Before thermal

Thermographic analysis of the above thermal image taken before the building renovations reveals increased temperatures. Increased temperatures are seen in red and yellow colours around the windows and below the eaves on this property. Warmer temperatures were also recorded on the ground floor suggesting that it's completely un-insulated. After remedial measures were taken much more consistent temperatures could be seen across the elevation. It must be noted that particularly cooler temperatures were seen across the ground floor suggesting much better overall insulation.

- Sempatap Insulation

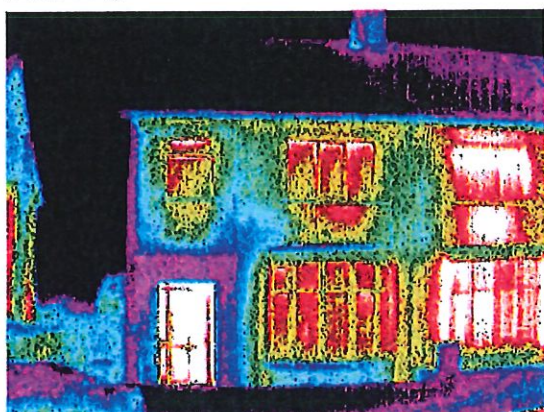
Before thermal

The thermal image entitled 'before' was taken previous to any renovation work. It can be seen by the warmer red and yellow colours that some minor increases of temperatures are present around the windows and below the eaves. The heat loss below the upper right window is the most inconsistent area. These areas of increased temperature are indicative of heat loss via missing/damaged insulation and/or via poor detailing at building junctions. Analysis of the property after remedial works were carried out revealed much less heat loss around the windows; however, inconsistency is still seen below the eaves and around the lower bay window. We suggest that this is investigated.

- Sempatap Insulation

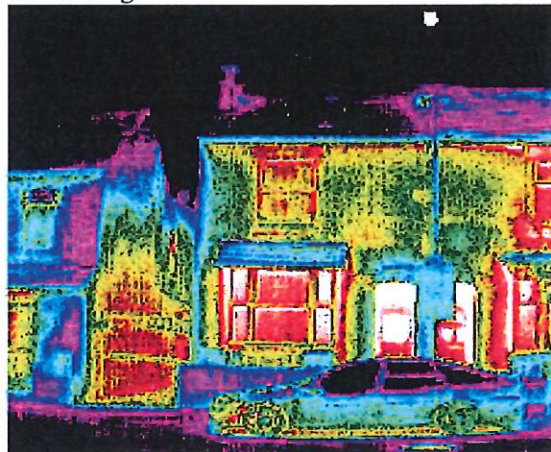
Before thermal

The thermal image entitled 'before' was taken previous to any renovation work. In the image an area of temperature inconsistency can be seen by the red and yellow colours to the top right of the lower window. Some minor increases in temperature can also be seen around the windows and below the eaves, this is indicative of heat loss via missing/damaged insulation and/or poor detailing. Analysis of the property after insulation has been applied reveals more consistent temperatures revealing a better level of insulation and thus less energy loss.

- Sempatap Insulation
