Thermographic Survey

Sempatap Insulation
On 8
Domestic Properties

Wolverhampton City
Council

Thermographic Survey Report

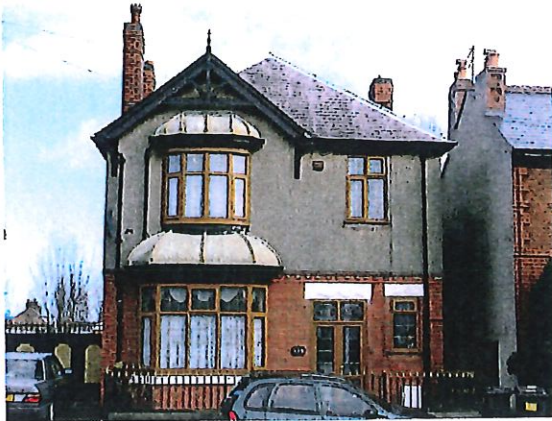
538 Wolverhampton Road Wolverhampton WV2 3DP

Thermographic analysis of the before shot, showed inconsistent temperatures in red and yellow colours. A large hot spot can be seen to the right of the bay window suggesting poor detailing at the junction; however, wind sheltering may also contribute. Increased temperatures are also seen below the upper right hand window indicative of missing/ damaged insulation; however the size and shape of the anomaly suggests that it is due to an internal heat source. Analysis after insulation reveals consistent temperatures across the entire elevation which indicates a well insulated property in good condition.

- Sempatap Insulation

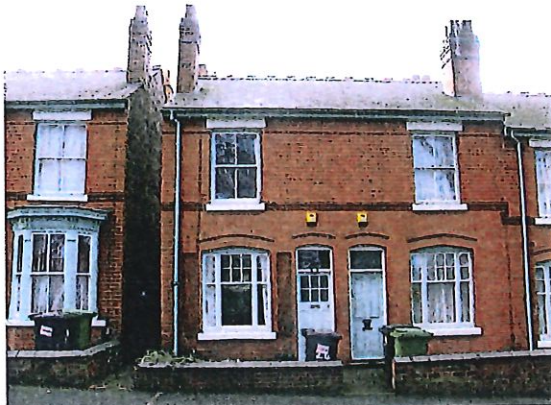
24 Fellows Street Wolverhampton WV2 4NU

In the before image, inconsistent temperatures can be seen in red and yellow colours indicating heat loss due to poor detailing or missing/ damaged insulation. Warmer temperatures are seen on the bottom level of this property suggesting heating is on compared to the above level; however it could simply be there is no insulation at all. Analysis of the property after insulation reveals significantly reduced heat loss across the elevation suggesting a much more energy efficient property.

- Sempatap Insulation

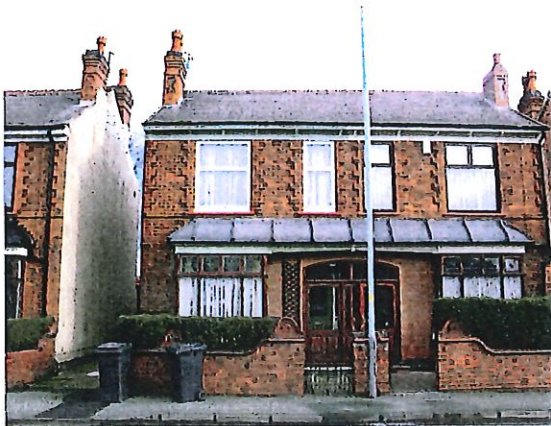
516 Wolverhampton Road Wolverhampton WV2 4PJ

Thermographic analysis of the above thermal image taken before the building renovations reveals increased temperatures to the left of the bottom window indicative of missing/damaged insulation and/or poor detailing. Analysis after remedial measures were taken reveals slightly more consistent temperatures across the property; however, increased temperatures indicative of heat loss can still be seen around lower windows. Although this is minor we advise that it is investigated further.

- Sempatap Insulation

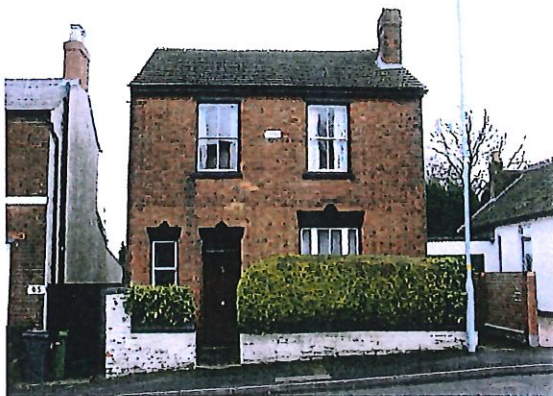
66 Upper Villiers Street Wolverhampton WV2 4NX

Thermographic analysis of the above thermal image taken before the building renovations reveals increased temperatures. Increased temperatures are seen in red and yellow colours around the windows and below the eaves on this property. Warmer temperatures were also recorded on the ground floor suggesting that it's completely un-insulated. After remedial measures were taken much more consistent temperatures could be seen across the elevation. It must be noted that particularly cooler temperatures were seen across the ground floor suggesting much better overall insulation.

- Sempatap Insulation

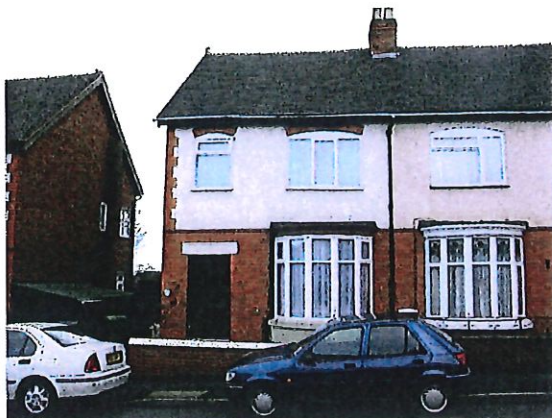
55 Upper Villiers Street Wolverhampton WV2 4NU

The thermal image entitled 'before' was taken previous to any renovation work. It can be seen by the warmer red and yellow colours that some minor increases of temperatures are present around the windows and below the eaves. The heat loss below the upper right window is the most inconsistent area. These areas of increased temperature are indicative of heat loss via missing/damaged insulation and/or via poor detailing at building junctions. Analysis of the property after remedial works were carried out revealed much less heat loss around the windows; however, inconsistency is still seen below the eaves and around the lower bay window. We suggest that this is investigated.

- Sempatap Insulation

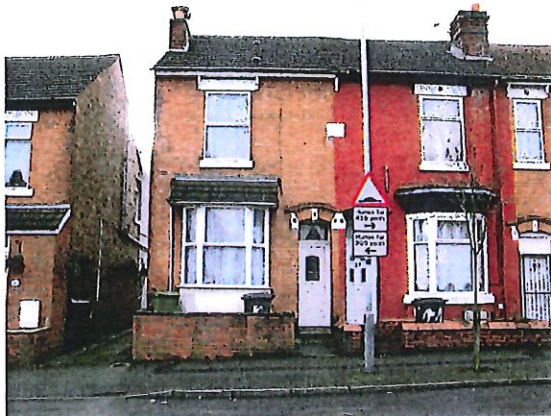
20 Wonderers Avenue Wolverhampton WV2 3HL

The thermal image entitled 'before' was taken previous to any renovation work. In the image an area of temperature inconsistency can be seen by the red and yellow colours to the top right of the lower window. Some minor increases in temperature can also be seen around the windows and below the eaves, this is indicative of heat loss via missing/damaged insulation and/or poor detailing. Analysis of the property after insulation has been applied reveals more consistent temperatures revealing a better level of insulation and thus less energy loss.
